Manhole Inspection Summary

Manhole # S35KK_027MH

Insp Date: **3/12/07 11:45 AM**

Location Address: **226 LAFAYETTE AVE**

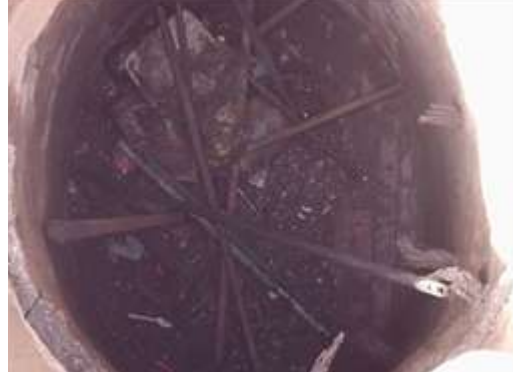
Top View

Corroded and missing steps. Channel debris.

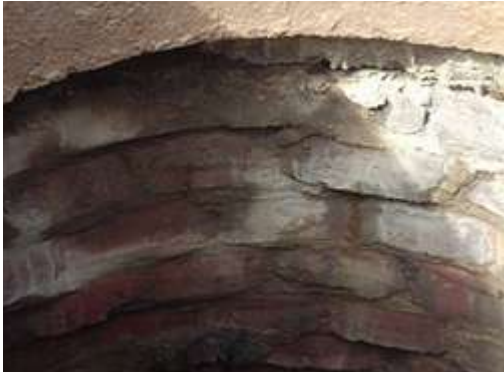
Defect

Frame leaks. Adjustment deterioration and infiltration. Corbel infiltration - other side.

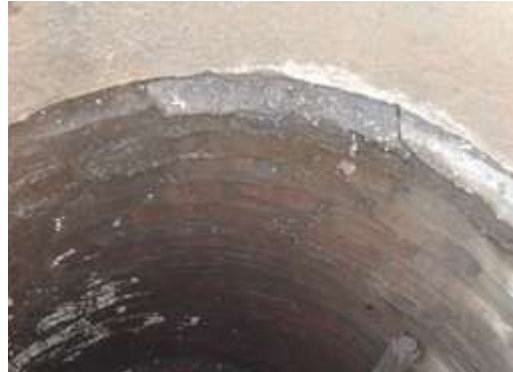
Defect

Frame leaks. Adjustment deterioration and infiltration. Corbel infiltration.

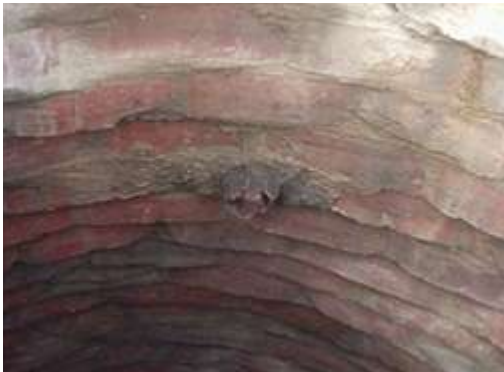
Defect

Corbel and Barrel infiltration. Valve

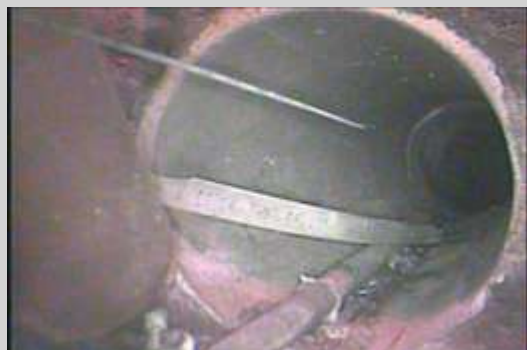
Pipe Out @ 12 O'Clock

Deposits: ☐ None ☐ Mud ☐ Sludge ☒ **Debris** ☐ Grease

Deposits Extent: **Light**
